Confidential Inspection Report

LOCATED AT:
123 Anywhere Place
Tulsa, Oklahoma 74035

INSPECTED ON:
Monday, February 29, 2016

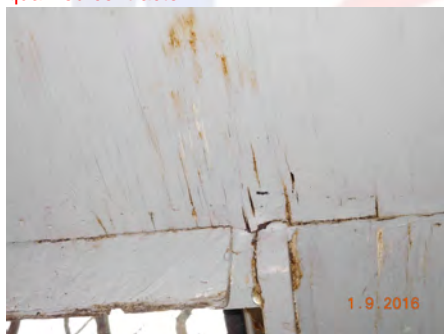
FASCIA & SOFFIT

There is wood rot and moisture damage to the soffit at the entry area. This should be further evaluated for repair and/or replacement by a qualified contractor.

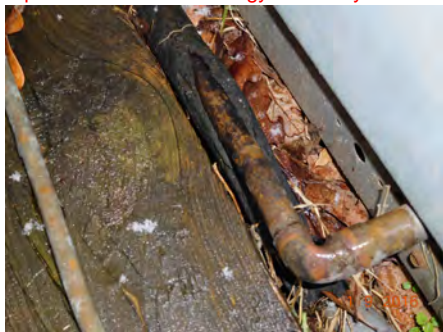
REFRIGERANT LINES

UPG Insulation is deteriorated and missing from portions of the refrigerant lines in several areas. We recommend that all missing insulation be replaced to increase energy efficiency.

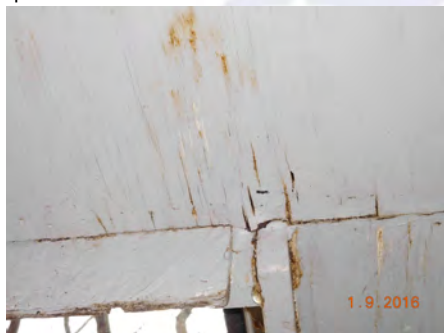
FASCIA & SOFFIT

1: - There is wood rot and moisture damage to the soffit at the entry area. This should be further evaluated for repair and/or replacement by a qualified contractor.

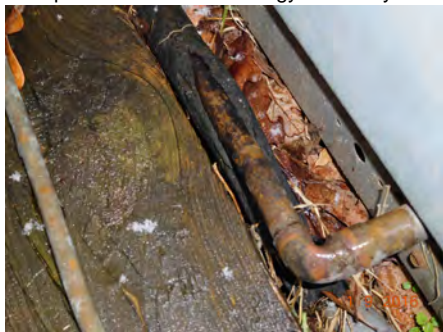
REFRIGERANT LINES

UPG 5: - Insulation is deteriorated and missing from portions of the refrigerant lines in several areas. We recommend that all missing insulation be replaced to increase energy efficiency.
